# 5 COMMON STEAM BOILER SYSTEM FAILURES

## WHAT TO LOOK FOR, WHERE THEY OCCUR AND HOW TO ADDRESS THEM.

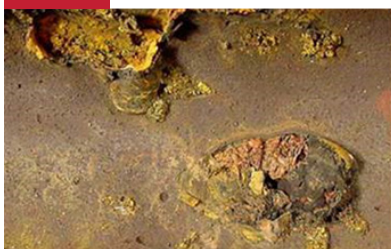
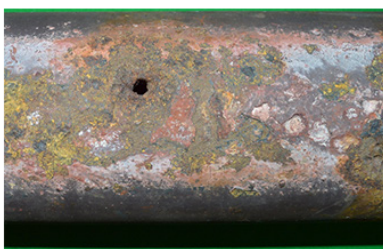
### 01 Oxygen Pitting Corrosion

**Appearance:** Deep, defined pits in metal surfaces, sometimes covered by corrosion deposits.

**Location:** Boiler tubes, deaerators, feedwater tanks and lines, economizers, and condensate systems.

**Causes:** Poor oxygen removal, oxygen entering offline equipment, or cold makeup water mixing with hot condensate.

**Corrective Actions:** Verify deaerator operation and venting, maintain proper oxygen scavenger treatment, and store offline boilers correctly.

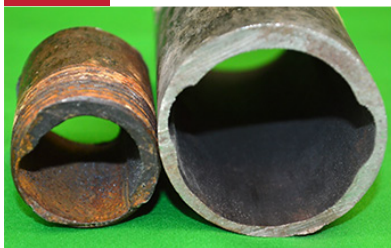
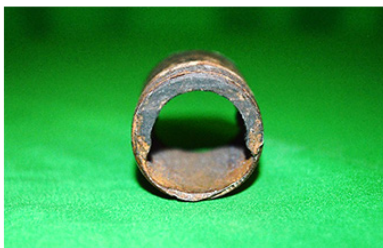
### 02 Carbonic Acid Attack

**Appearance:** Thinning or grooving in heat exchangers and condensate piping, often first seen at leaking threaded joints.

**Location:** Steam distribution and condensate return lines.

**Causes:** Carbon dioxide from makeup water alkalinity can travel with steam and form corrosive carbonic acid in the condensate.

**Corrective Actions:** Lower feedwater alkalinity, keep open feedwater tanks above 170°F, maintain proper venting, and use appropriate condensate treatment.

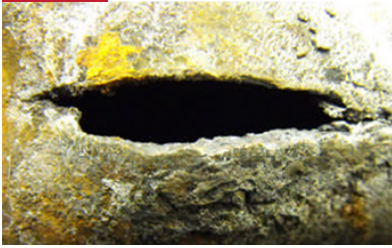
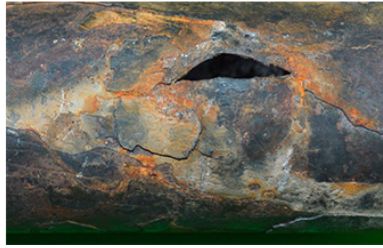
## 03 Overheated Tubes

**Appearance:** Thick-lipped failures have rough, heavy edges; thin-lipped failures show smooth, knife-like edges.

**Location:** Economizer and boiler tubes.

**Causes:** Long-term overheating from firing issues, flame impingement, or scale; short-term overheating from blocked flow or low-water conditions.

**Corrective Actions:** Maintain proper water chemistry, control scale buildup, verify burner alignment, and ensure correct boiler operation.
